# Manhole Inspection Summary

## Manhole # S13C1\_013MH

Insp Date: **12/18/08 11:14 AM**

**Location** Address: **1401 Bloomfield Ave.**

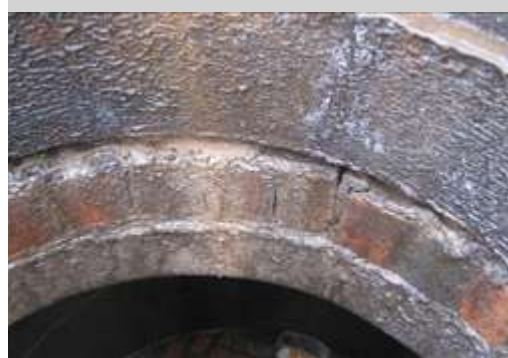
Defect 4

Infiltration: ☐ None ☐ Joint ☐ Cracks ☒ **Mortar** ☐ Roots ☐ Wall

missing mortar causing chimney infiltration

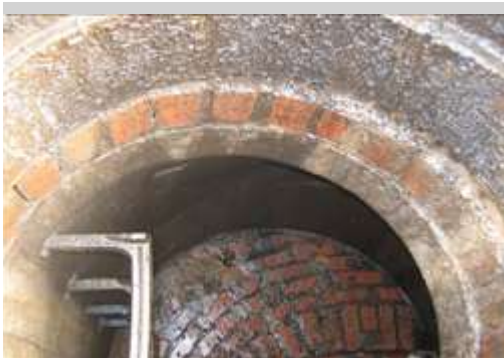
Defect 2

**Frame** Offset: **0** (in.) Condition: ☐ Sound ☐ Cracked ☒ **Leaks**

frame, chimney and corbel infiltration

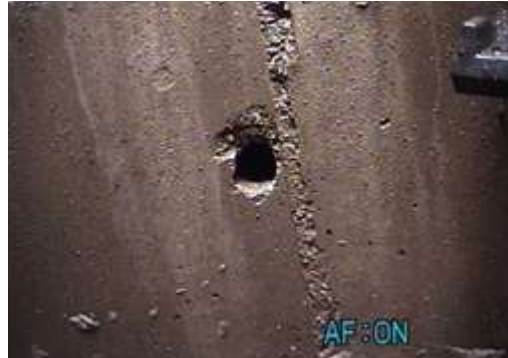
Defect 1

Condition: ☐ Sound ☒ **Cracked** ☐ Root Intrusion ☐ Loose Brick ☐ Deteriorated

Infiltration: ☐ None ☐ Joint ☐ Cracks ☐ Mortar ☐ Roots ☒ **Wall**

hole in barrel, barrel infiltration

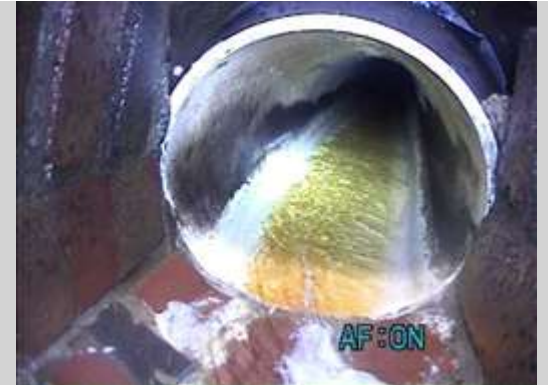
12 O'Clock Outflow

8 in. Circular Gravity Sewer  
Pipe Out @ 12 O'Clock

Pipe Height: **8.4** (in.) Rod and Bar (Angled)  
Pipe Material: **PVC** ☐ Pipe Lined  
Invert Depth: **7.12** (ft.) Flow Characteristics: **Slow**  
Deposits: ☒ None ☐ Mud ☐ Sludge ☐ Debris ☐ Grease  
Silt Depth: **0** (in.) Deposits Extent:  
Infiltration: **None** Pipe Seal Cond: **Sound**

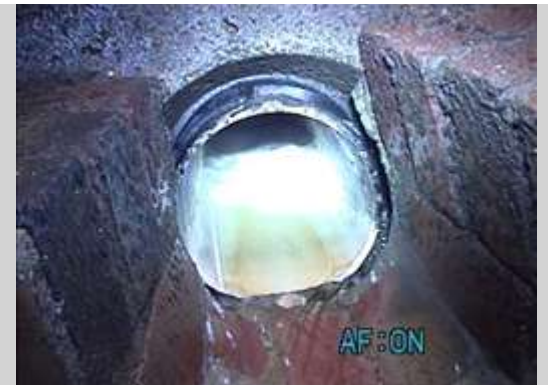
3 O'Clock Inflow

6 in. Circular Gravity Sewer  
Pipe In @ 3 O'Clock

Pipe Height: **6** (in.) Rod and Bar (Angled)  
Pipe Material: **PVC** ☐ Pipe Lined  
Invert Depth: **6.88** (ft.) Flow Characteristics: **Slow**  
Deposits: ☒ None ☐ Mud ☐ Sludge ☐ Debris ☐ Grease  
Silt Depth: **0** (in.) Deposits Extent:  
Infiltration: **None** Pipe Seal Cond: **Sound**
